Replacing the inner waist seal on a Tourer using the LWB inner waist seal.....By Michael Hewitt

Many Tourers are suffering from corrosion within the offside rear door inner waist seal

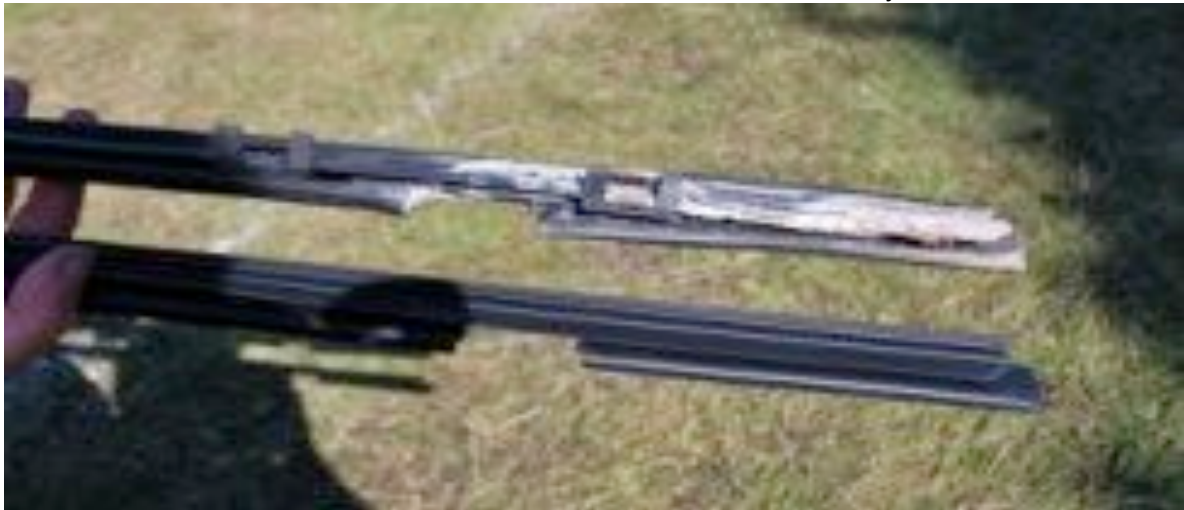
The true extent of the corrosion in the seal will then be fully visible:

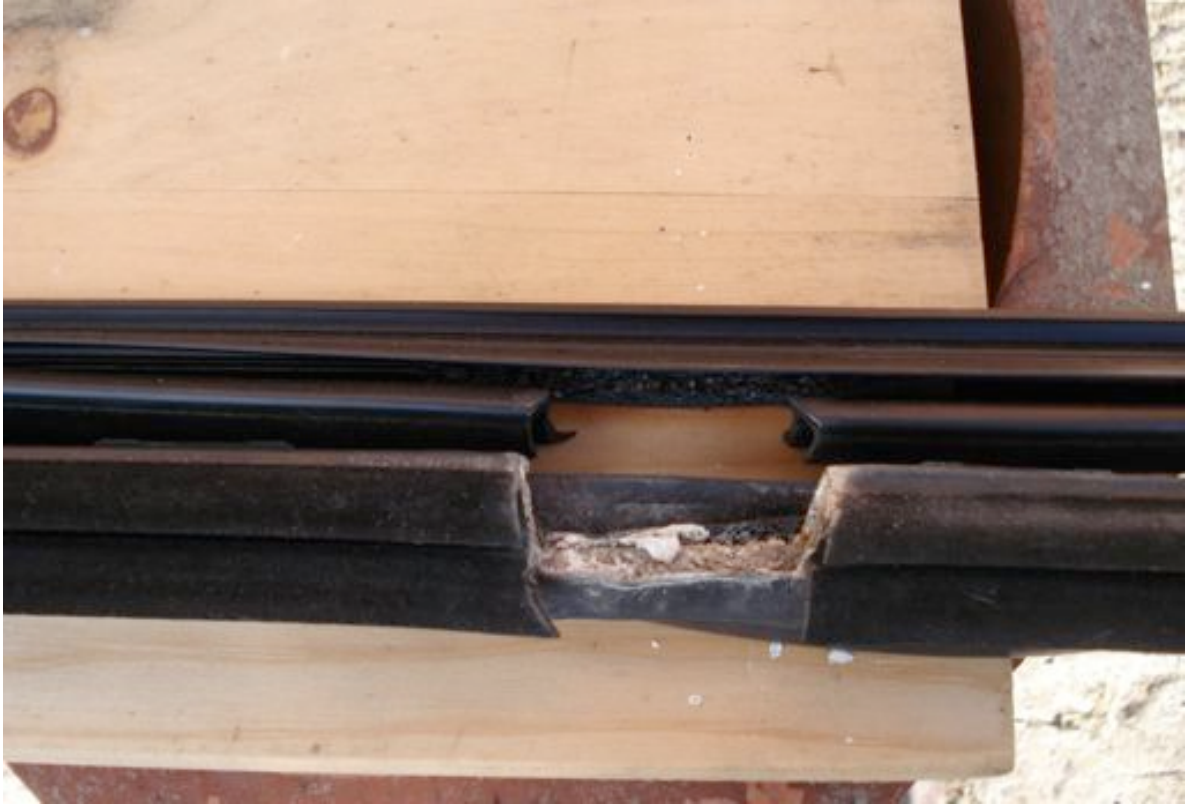
The corrosion extends to the groove cut into the seal for the rear quarter light,

This corrosion is not usually visible when the seal is in place.

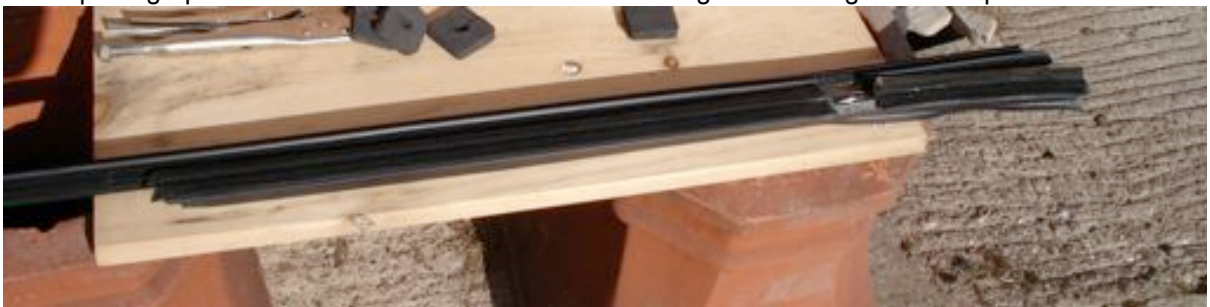
The replacement LWB waist seal is longer than the Tourer seal so the LWB seal will need to be trimmed to size at the leading edge. The cut out for the quarter light obviously dictates this but it does mean that the trailing edge of the replacement seal is a little bit short.

The photograph below illustrates the difference in the length of the original and replacement seals.

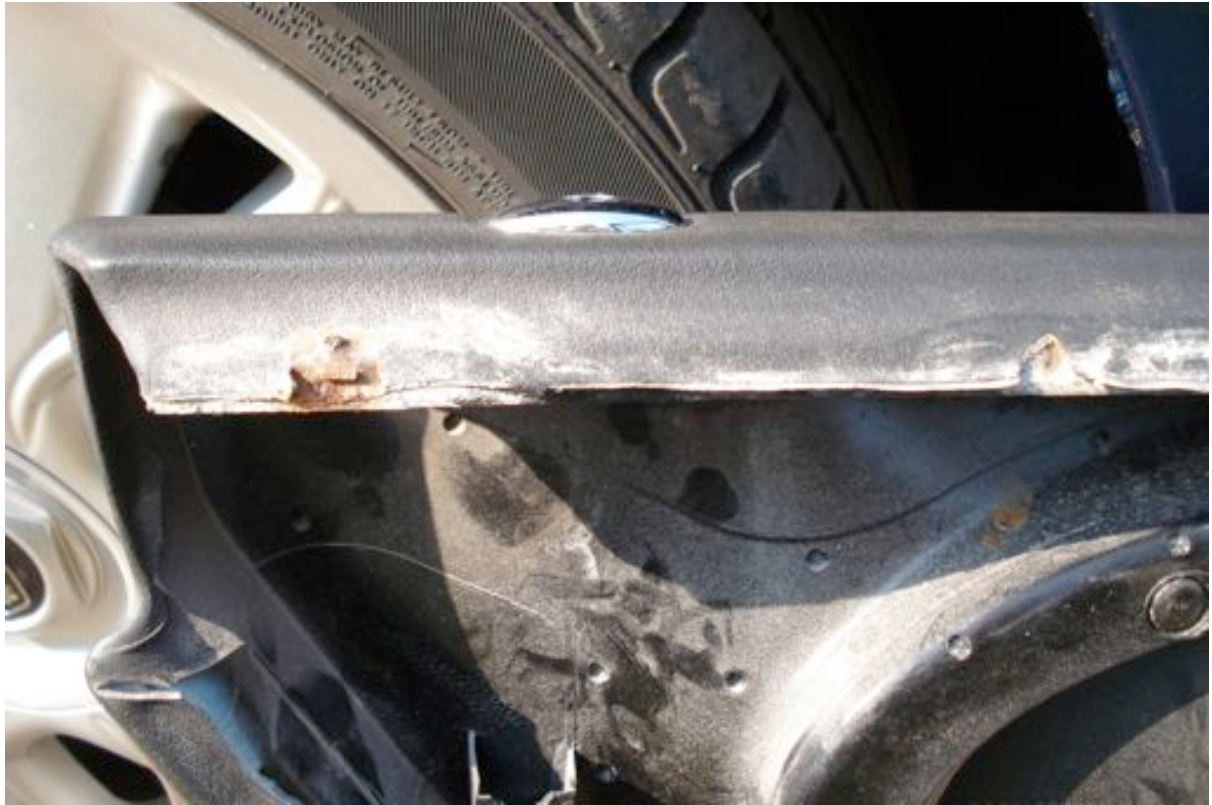
Corrosion has affected the metal of the door where the rear most fixing clip was seated; this was removed and treated with a rust inhibitor. Although the door cards are non-metallic some rust had become encrusted where it met the corroded door metal and clip.

This was removed and a rust inhibitor was brushed onto the affected area. Some of the original clips were reused however one had been completely corroded and another showed slight signs of corrosion so these were replaced with new clips. These clips fix the seal to the door and also secure the top edge of the door card to the door.

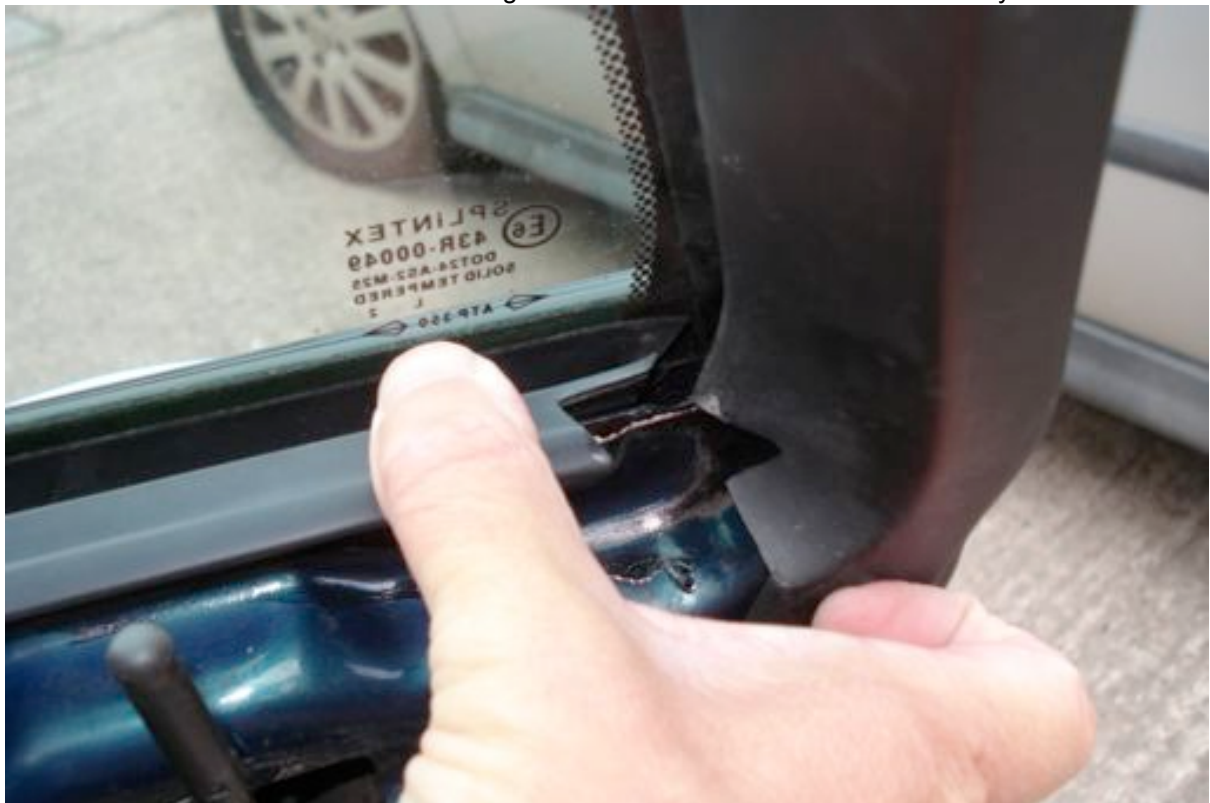
The rear of the seal is a little too short so you will need to cut a piece from the original seal to make up the difference. To prevent rattles I cut a section that could be made secure by applying a bead of black silicone. However I am also using this to monitor what was the most heavily corroded area.
