Replacing the inner waist seal on a Tourer using the LWB inner waist seal.....By Michael Hewitt

Many Tourers are suffering from corrosion within the offside rear door inner waist seal

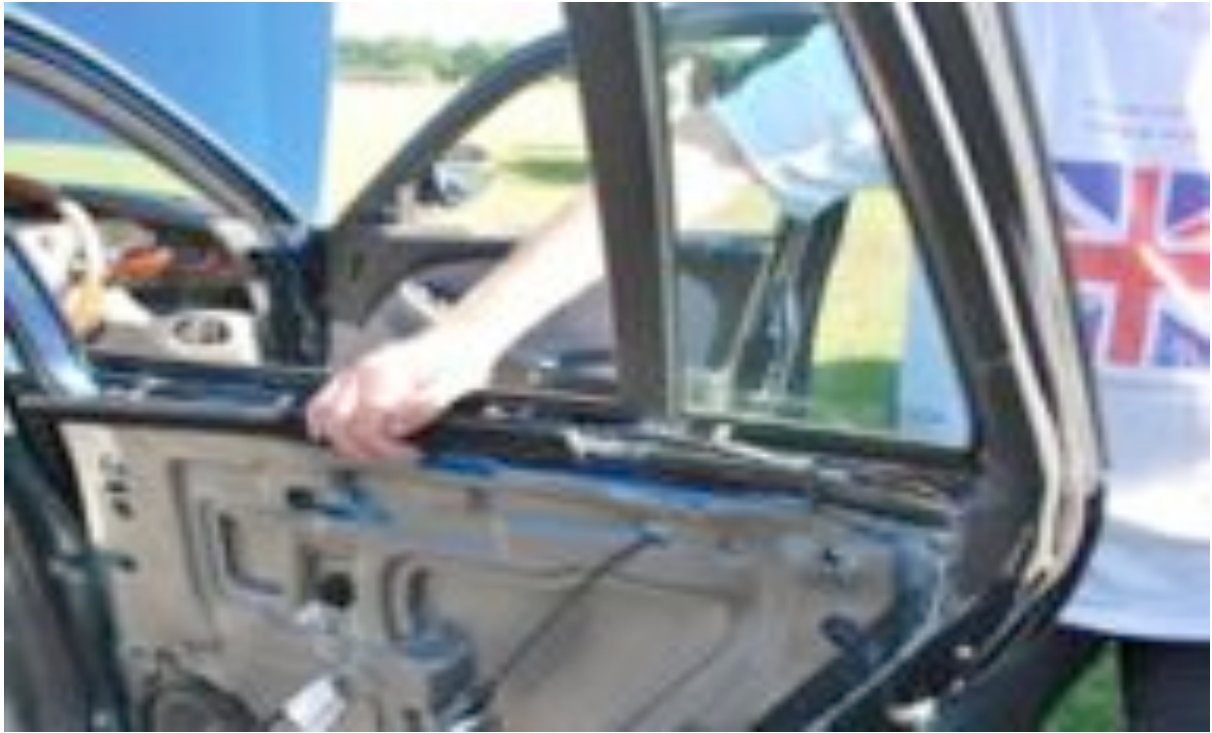
To start you will need to remove the door card and ease the lower parts of the inner plastic door trim away from the window frame:
